The manufacturer of aluminum brake calipers was in the final phase of designing the casting process of a new caliper. Serial production was taking place on two semi-automatic prototype machines and on one fully automatic casting line. Ultimately, the prototype machines are to be replaced by subsequent automatic lines, however this must wait – the supplier estimated the lead time at 7 to 9 months. Therefore, until that time, the prototype machines must be used.

What is the problem?

First approach to finding the root cause

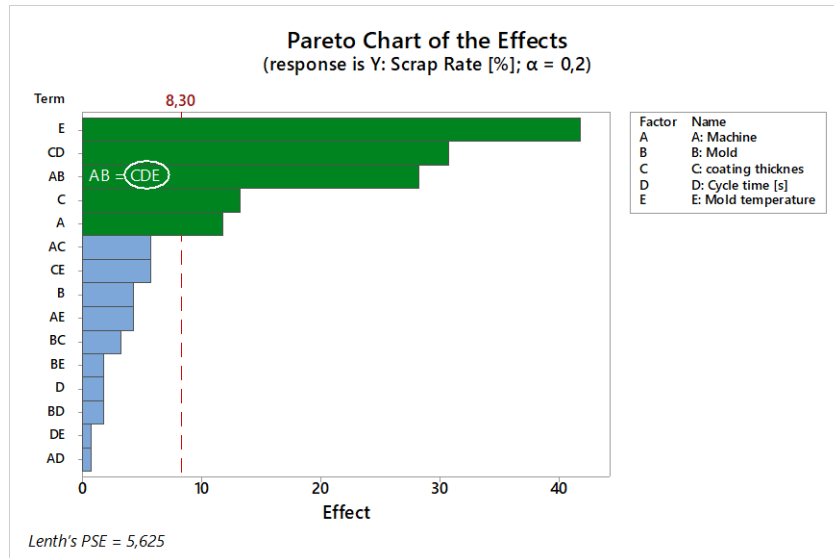
this defect. Y, that is the response from the experiment, is a simple proportion of bad parts in a given run to 10 – that is all produced in a given configuration. In seven runs of the DoE the fraction of bad parts was 0% in the remaining from 10 to 90% of bad parts. The Pareto chart below shows active effects.

Taking into account sizes of effects (that is by how many percent we are able to influence the number of cracks) as active we mark those which are greater than 10%. Additionally, remembering about alias structure and due to illogical course of interaction AB as active we mark the 3rd order interaction CDE.

A: Machine	-11,79
C: Coating thickness	13,21
E: Mold temperature	41,79
C: Coating thickness*D: Cycle time [s]	30,71
C: Coating thickness*D: Cycle time [s]*E: Mold temp	28,21

Using these effects, it is possible to explain over 95% of variation created in this DoE.

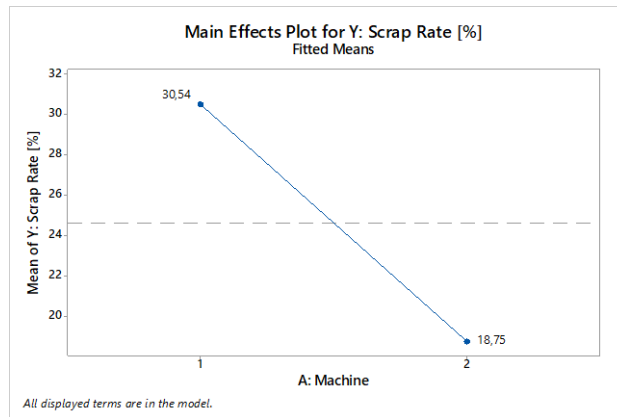
The only effect which is not in interaction with other factors tested in this DoE is factor A. Lack of interaction means that effect A will proceed in a similar way, regardless of how the remaining factors are set. The effect of machine 1 vs 2 is shown in the chart below.

Effect A: Machine confirms that the difference in number of cracks can be attributed to machine 1, which during the DoE produced on average 30.54% of bad parts per run. Mold M6, which was also suspected of causing errors, turned out not to be significant.

On the chart above it can also be seen that it was machine 1 and not mold M6 that was responsible for creation of most cracks. The reason for this was the fact that due to location of the thermocouple in prototype machines, machine 1 showed underestimated actual temperature of the mold in the area of defect formation, hence it was more susceptible to overheating and thus defect formation.

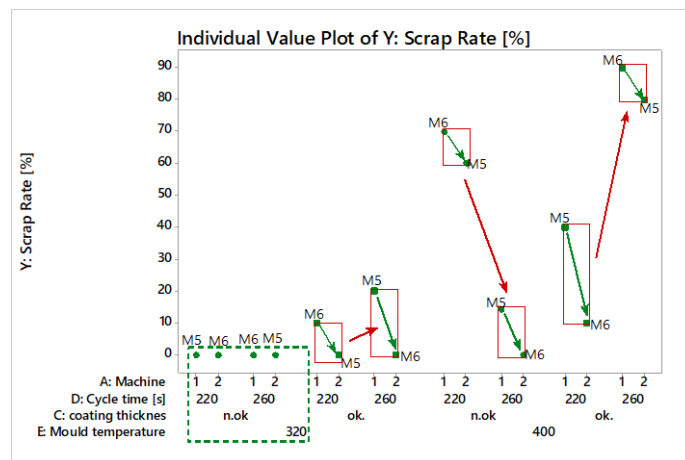
The remaining factors C: coating thickness, D: solidification time and E: mold temperature are in active interaction, which means that analyzing their main effects does not make sense, because they will depend on the setting of each of these factors. The easiest way to see this is on the Box Plot shown below.

The main factor causing cracks is mold temperature. However it does not automatically mean formation of cracks. At the same time lowering this temperature does not guarantee that there will be no cracks. Only learning the interaction CDE shows that at reduced mold temperature and lower thickness of insulating coating we obtain 0 cracks. We can in such setting choose cycle time, there are also no differences between machines.

What was called a crack (visually it could look like that) was in reality a micro tearing out of not fully solidified casting from the mold. The established level of thickness of the insulating layer in this area of the mold was too high, which caused overheating of the casting. Ultimately it will be necessary to reduce insulation in this area, so that the casting is able to fully solidify.
